**UNITED STATES DISTRICT COURT  
NORTHERN DISTRICT OF CALIFORNIA**

CHART INC.

Case No. 3:20-cv-4984

**COMPLAINT AND  
DEMAND FOR JURY TRIAL**

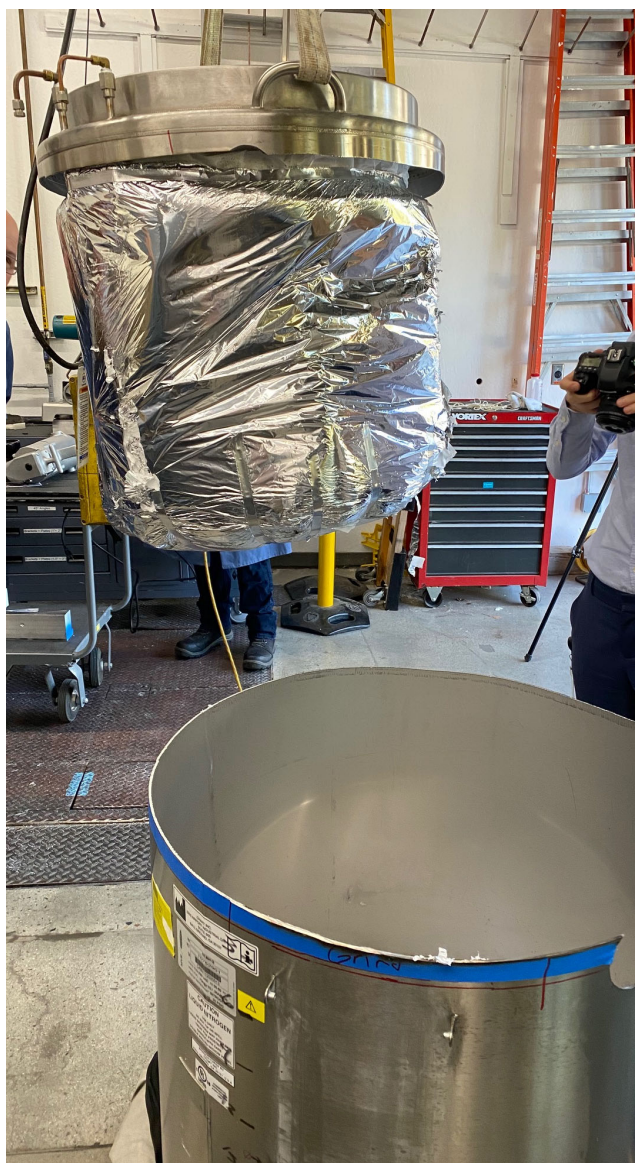
19. The picture below was taken following failure of Tank 4 and shows the tank's inner vessel (wrapped in reflective material) being removed from the outer vessel. In between the two vessels was an interstitial space. Before a tank is put into service, Chart draws a vacuum within that space by sealing it shut and pumping out the air. The resulting vacuum space is what allows cryopreservation tanks to keep liquid nitrogen and biological samples at  $-198^{\circ}\text{C}$ .

*Tank 4's inner vessel suspended after removal from outer vessel (vacuum space was in between)*

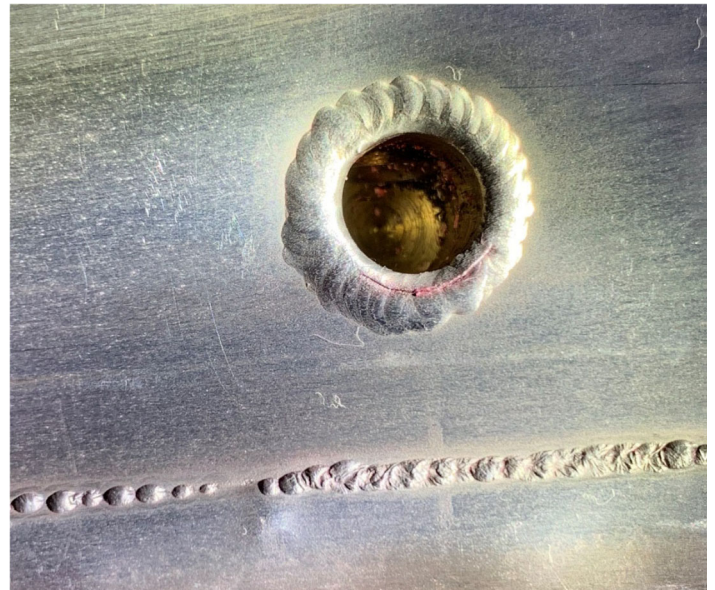
27. The image on the right is the same weld, this time after using Magnaflux Spotcheck liquid dye penetrant. The fact the red dye penetrant remained after the surface was wiped clean is indicative of a crack.

*Red dye indicates a crack in the weld*
